Wetland Survey Report: Greater Los Angeles Healthcare System West Los Angeles Medical Center Master Plan Redevelopment

United States Department of Veterans Affairs
Greater Los Angeles Healthcare System

January 31, 2018

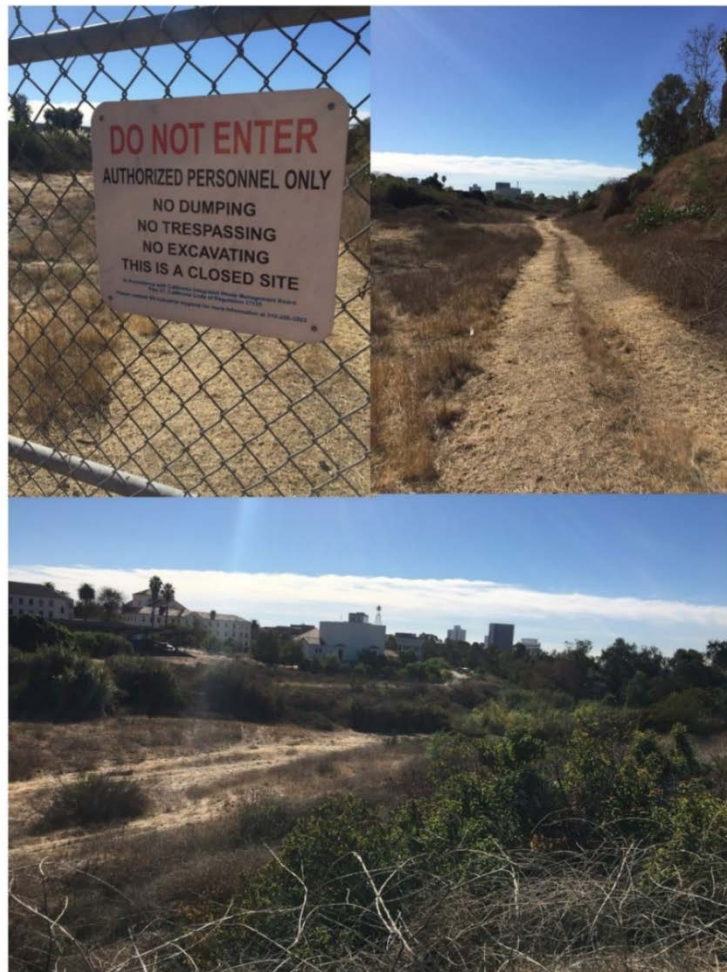
Figure 2. North End of Arroyo

The initial ground-truthing and data gathering survey to identify wetlands took place within the arroyo on the northwest side of the WLA Campus, south of the Brentwood School baseball field, east and southeast of Veterans Barrington Park, and west of MacArthur Field, the Brentwood Theatre, and the solar array on the WLA Campus. The arroyo is fenced with open space and no structures are present within the fence line (Figure 2).

Top left: View from outside of fence at north end of arroyo, looking south from Brentwood school baseball field. Top right: View from inside of fence at north end of arroyo looking south. Bottom: Looking southeast from high point at the southeast corner of sports fields at Veterans Barrington Park.

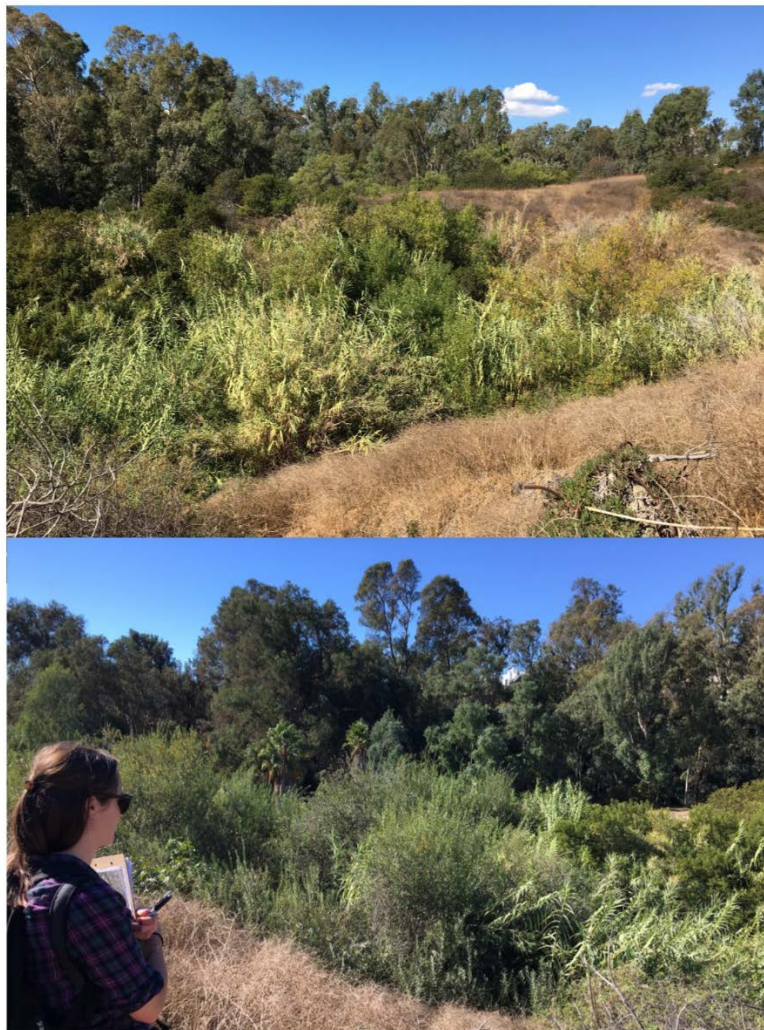
Figure 3. Overlooking Wetland Area, Looking from East Side to West

The area of wetland starts downhill from where the first outflow drain emerges and is characterized by a deeply eroded channel below the drain structure. This area contains mostly invasive mustard, other upland species, and various refuse, clothing, and books. Wetland or riparian vegetation is absent surrounding the outflow. Approximately 15 to 20 feet south of the first drain is a larger, fenced outflow, which appears to be the main outflow and energy dissipation structure from the 1996 storm drain extension. This outflow is approximately 10 to 15 feet below the top of the eroded slopes. Riparian and wetland vegetation is present surrounding and downstream from this structure. Water was auditorily observed by the survey team near the bottom of the outflow area, but it could not be seen due to visually dark conditions at the bottom of the outflow area. Figure 2 shows views of the northern arroyo area, and Figure 3 shows the dense vegetation surrounding the wetland area.

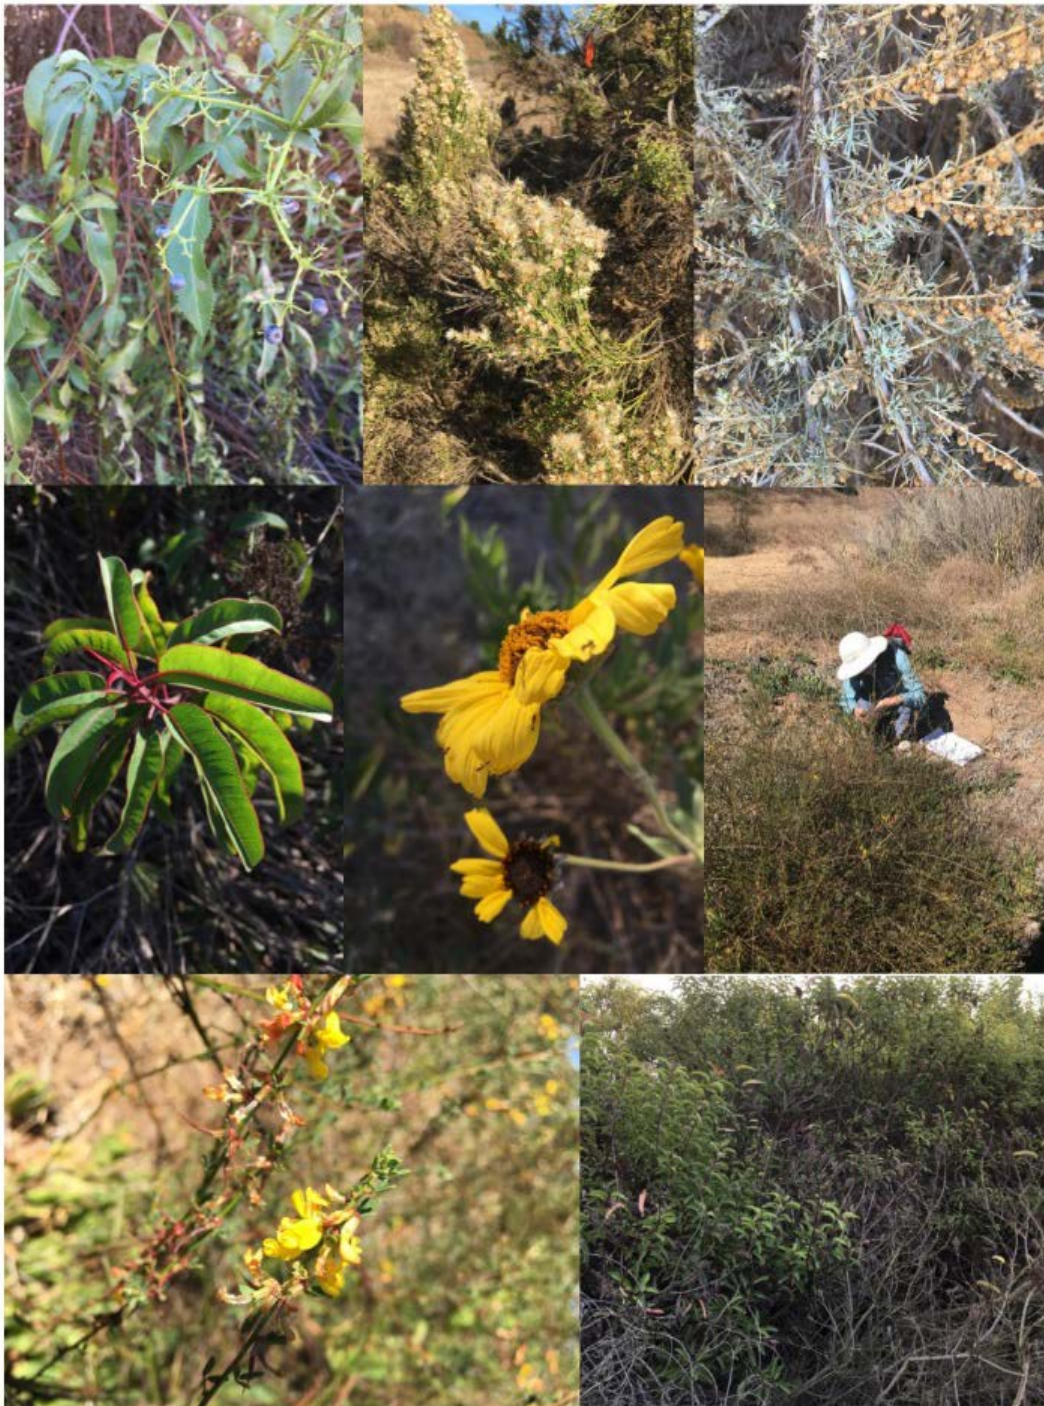
Figure 5. Upland Vegetation Species Observed in Arroyo at WLA Campus

During the survey of the wetland area perimeter and while attempting to access the bottom of the arroyo, it was noted that some soils in the bottom of the vegetated area may not receive sunlight due to the density and composition of arundo. A variety of native and non-native upland vegetation were recorded while seeking access points. Table 1 identifies vegetation within the upland arroyo area and surrounding the wetland; Figure 5 displays photographs of species identified in Table 1.

Top left: blue elderberry; Top center: coyote bush; Top right: California sagebrush; Center left: laurel sumac; Center center: California encelia; Center right: surveyor with deerweed in foreground and ice plant; Bottom left: deerweed; Bottom right: dense stand of laurel sumac

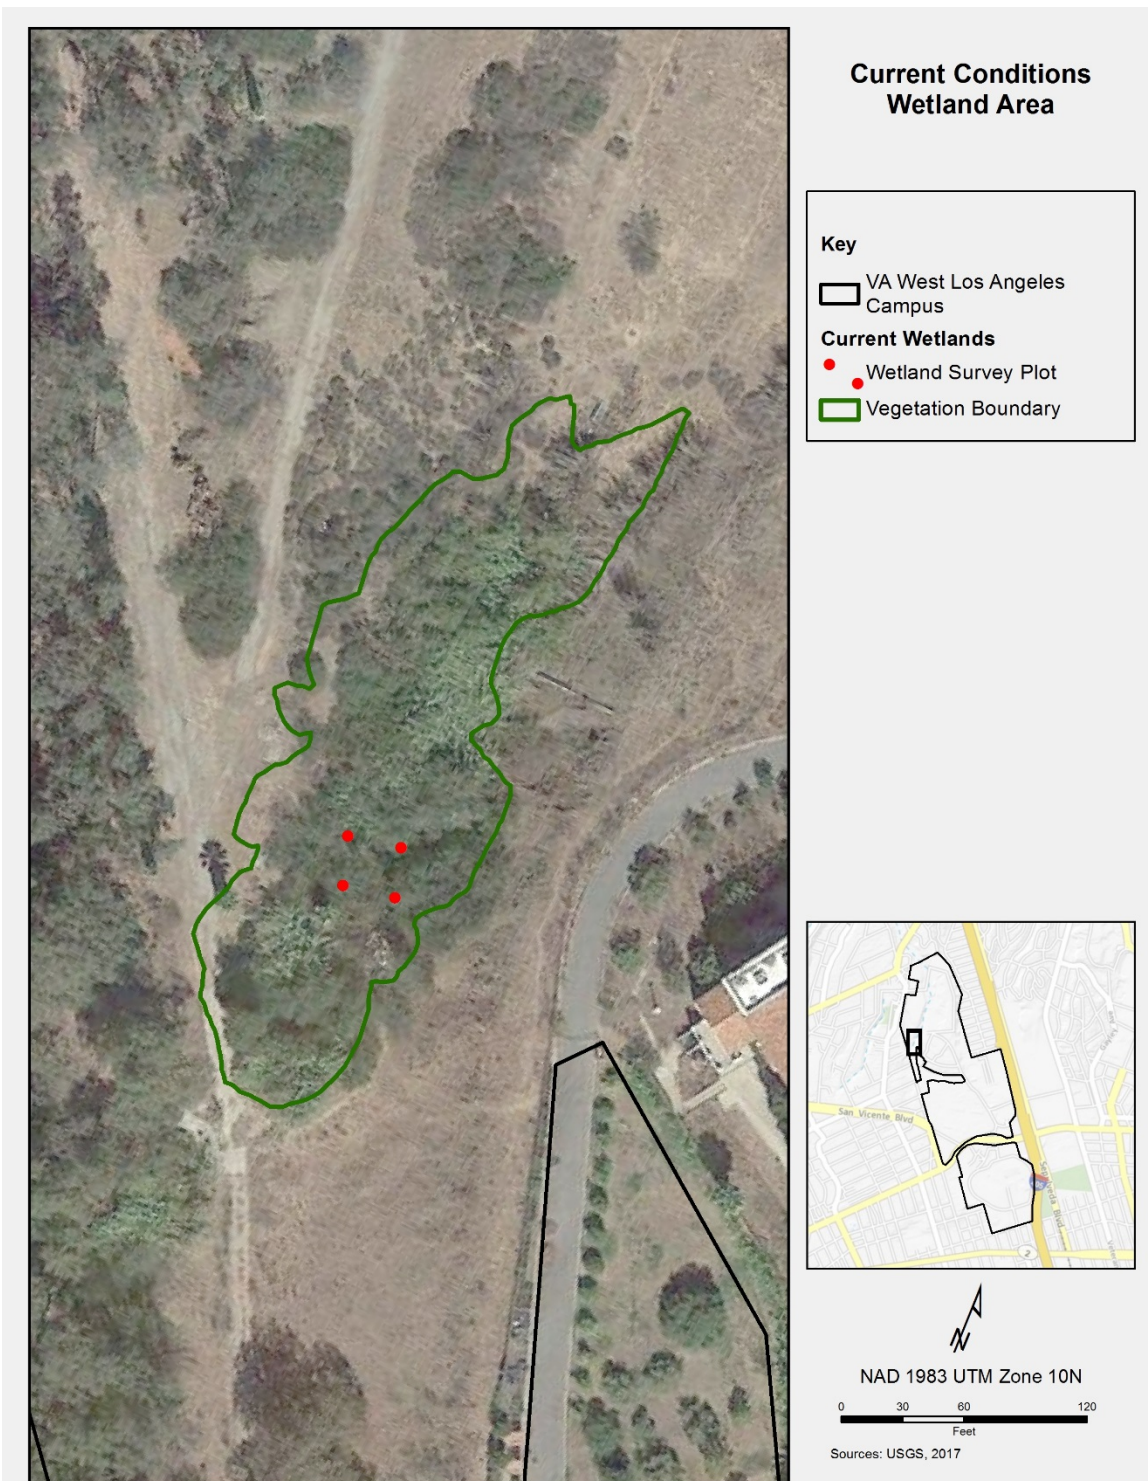
Figure 6. Wetland Survey Plot

The wetland survey plot (Figure 6) is located approximately 200 feet south of the storm drain outflow. The saturated land is oriented from north to south, with a steep bank (approximately 30-degree slope) on the east side and a gradually sloping bank on the west. Figure 7 shows images facing east and west from the survey area. The vegetation and hydrology are suspected to be a result of the 1996 storm drain installation and wetland restoration project (Lui, 2000). The entire area was disturbed and had recently been cleared of trees and arundo, with much of the cut vegetation remaining on the ground. Access to the bottom of the arroyo was cleared, making a survey possible. The conditions of the survey plot and surrounding area were atypical compared to the rest of the wetland area because much of the overstory vegetation had been removed and sunlight was able to penetrate to soils below. Additional features noted in the survey plot were discarded books, toys, clothing, and other refuse.

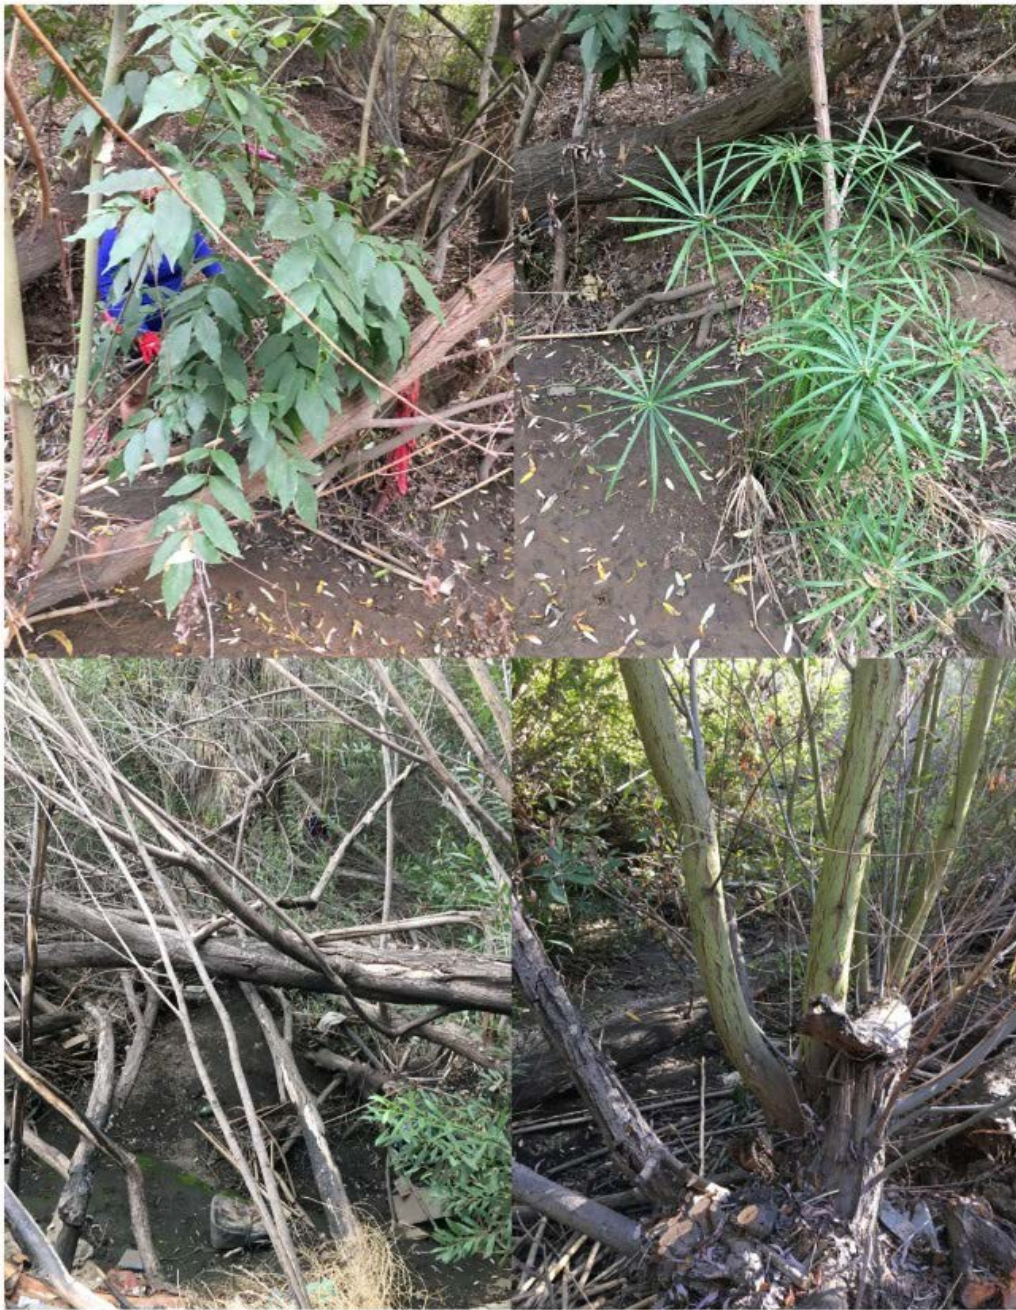
Figure 8. Vegetation within Wetland Survey Plot

Most of the wetland survey plot was bare ground or land covered with cut branches, although a few herbaceous species were identified. One fungi species, an unidentified gilled mushroom, was noted growing in the ground near the trunk of a willow tree. Arroyo willow and arundo were the dominate cover species in the wetland survey plot and both are facultative wetland species listed in the USACE Arid West Region NWPL. Figure 8 displays several of the vegetation species within the survey plot; Figure 9 displays the fungi and surrounding vegetation.

Top left: Shamel ash and arroyo willow branches; Top right: umbrella plant; Bottom left: arroyo willow with arundo in background; Bottom right: arroyo willow with cut branches

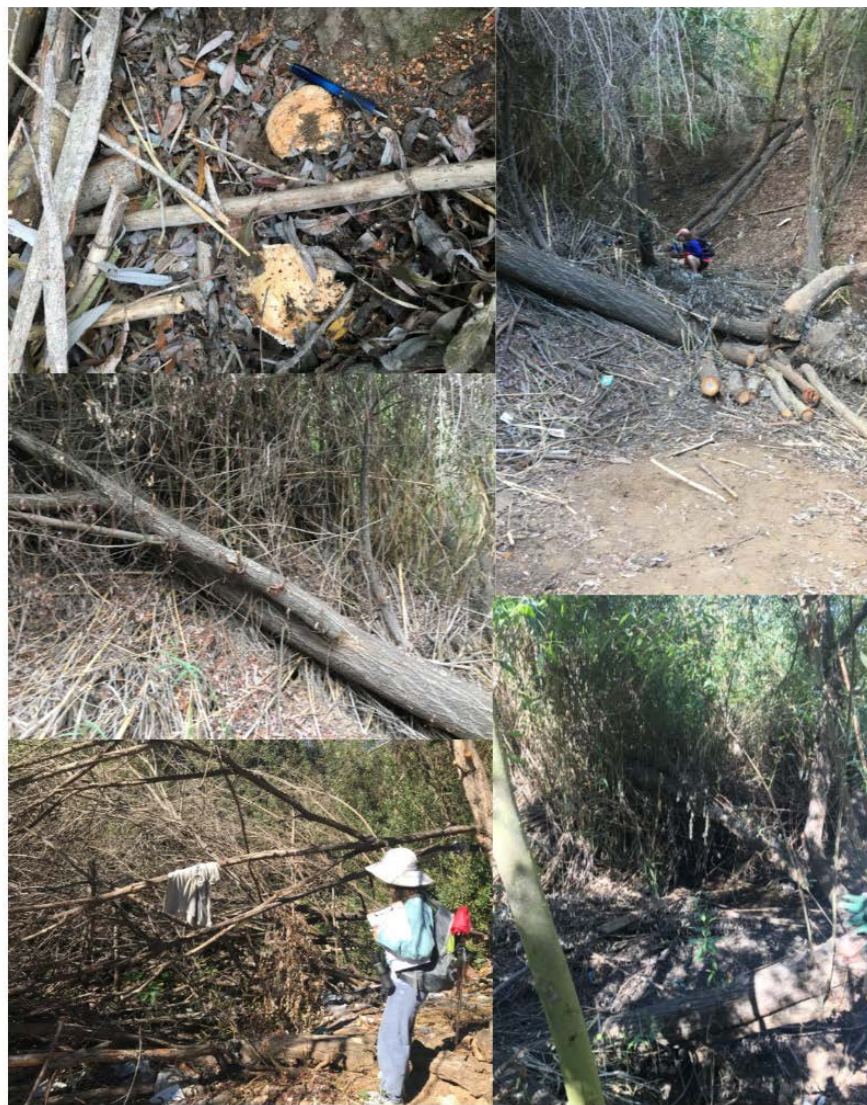
Figure 9. Examples of Observed Vegetation Surrounding Wetland Survey Plot

Top left: cut branches and gilled mushrooms; Top right: cut willow and arundo; Center left: arundo with large willow log; Bottom left: willow branches; Bottom right: willow and arundo

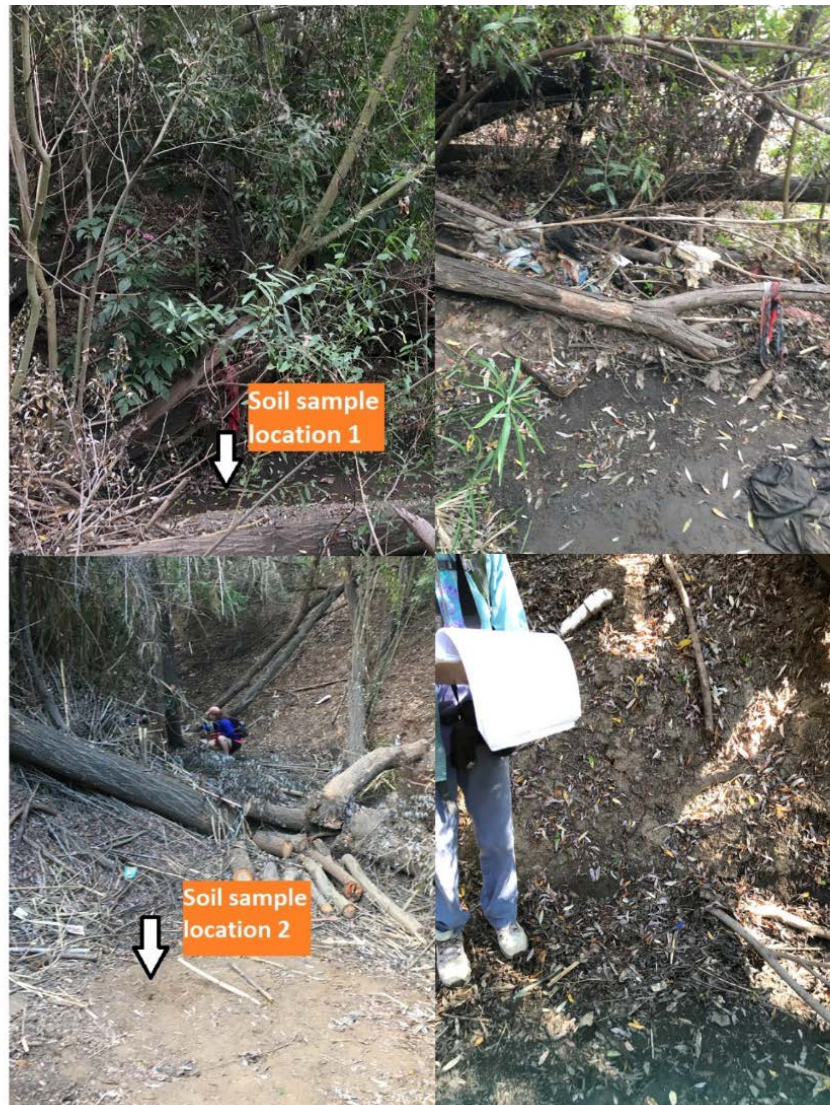
Figure 10. Soil Sample Locations and Capillary Fringe

Most of the wetland survey plot was bare ground or ground covered with brush and leaf litter. Upland soils were dry, but toward the bottom of the slopes, the soils were moist and showed the presence of water. A capillary fringe was present where the steep slope on the east side of the channel intersected

with the damp soils at the bottom of the channel (Figure 10). Soils observed in the moist areas consisted of coated sand, gravel, silt, with a thin layer of dark, sticky silt at the surface.

Two soil samples were taken: one sample from the center of the wetland survey plot within the saturated soil, and another sample from the lower bank on the west side, about one foot from the visible line of moist soils. Core samples of soils were obtained using an auger at a depth of 6 to 7 inches. Based on the Munsell Color Charts, the soil color at sample point one ranged from dark olive gray (5Y, 3/2) to very dark greyish brown (2.5Y, 3/2), and at sample point two from light olive brown (2.5Y, 5/3) to olive (5Y 5/3). The soil texture from sample point one was sandy clay loam with silt loam on the surface, whereas the soil texture for sample point two was silty clay loam. The soil color at both sample points may indicate potential of saturated soil conditions; however, no obvious hydric soil characteristics such as mottling, reduced², or gleyed matrix³ colors were identified in the soil samples. Soil pits were not used, so detailed observations and analysis of soils within the wetland survey plot are limited. Figure 10 displays soils and locations where the samples were taken.

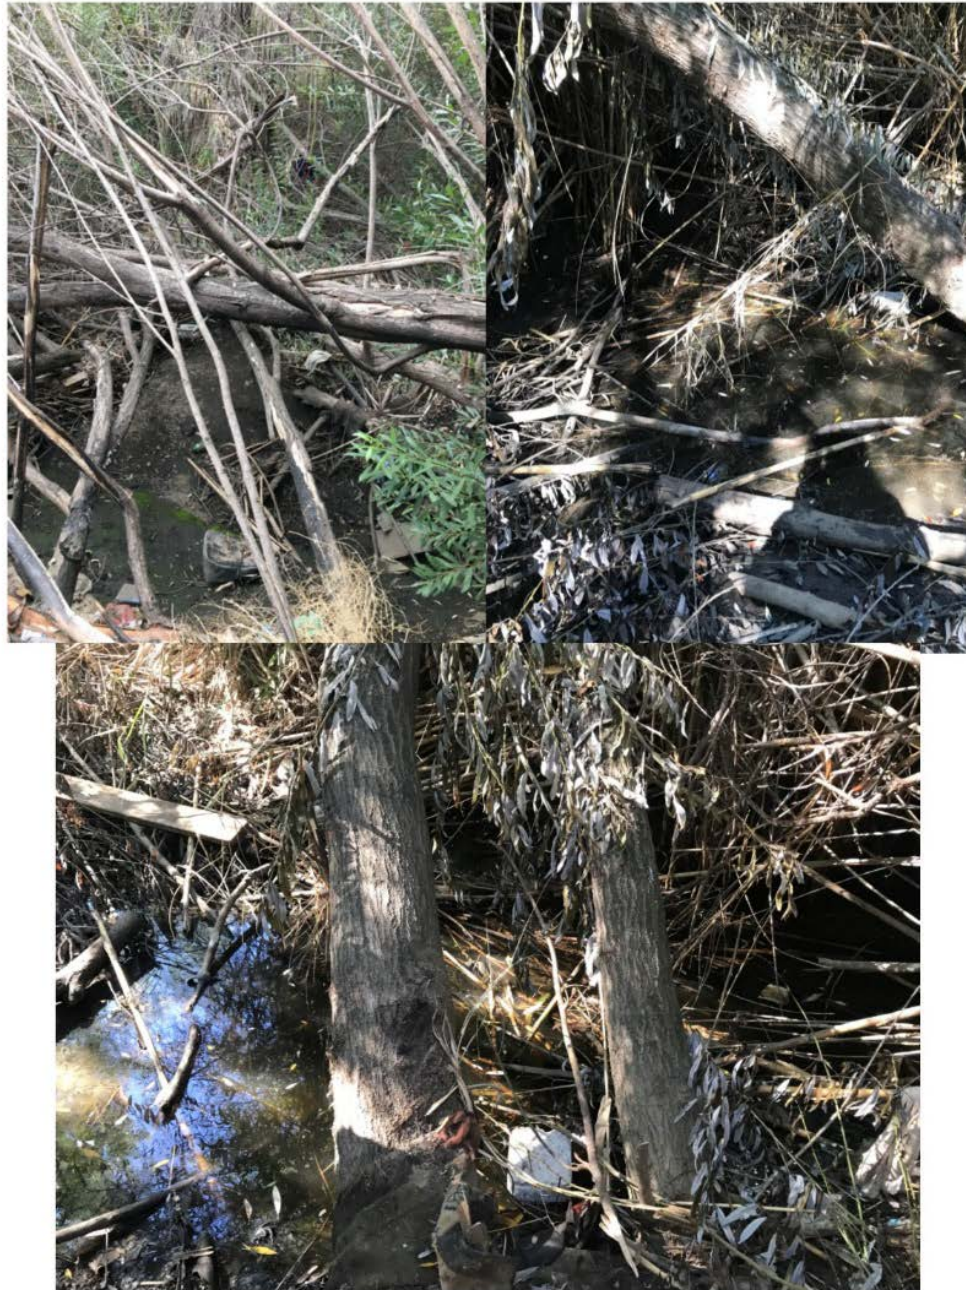
Figure 11. Hydrology Features Within and North of Wetland Survey Plot

Hydrology indicators included standing water just upstream of the wetland survey plot. The standing water was measured at approximately 9.5 inches deep about 2-feet from the downstream edge. Aquatic invertebrates, possibly mosquito or midge larvae, were observed. The water had a thin layer of oil or scum and was slightly cloudy. The survey team took care to not come into direct contact with the water due to the visual conditions and the presence of refuse. The team was unable to determine if the standing water was being contained by fallen logs and vegetation or if the water was within a low point in the arroyo. The team was also unable to ascertain how far upstream standing water was present due to the limited access. Downstream of the standing water, within the wetland survey plot, the soils were moist

and a capillary fringe of about 6 to 12 inches was present along the banks of the arroyo. Figure 11 shows hydrology features within and upstream of the wetland survey plot.
